Manhole Inspection Summary

Manhole # S53C__044MH

Insp Date: **6/13/08 10:12 AM**

Location Address: **3108 e fayette st**

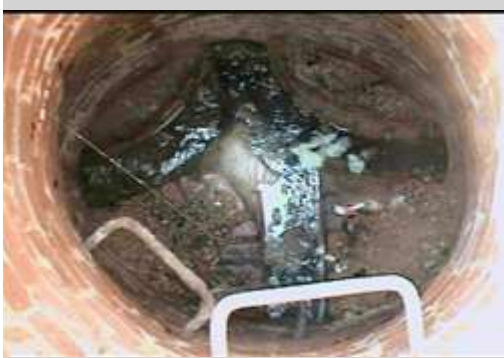
Defect 2

Count: **3** Missing: **0** ☒ **Corroded**

steps corroded

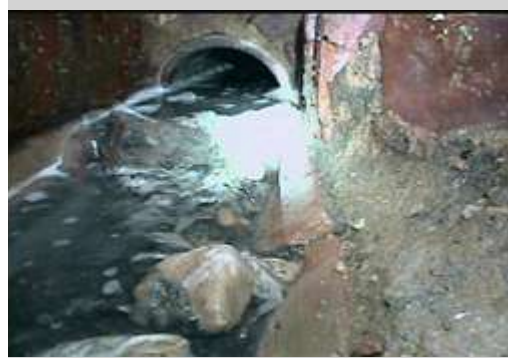
Defect 4

Condition: ☐ Sound ☐ Cracked ☐ Root Intrusion ☐ Deteriorated ☐ Leaks ☒ **Debris**

channel debris

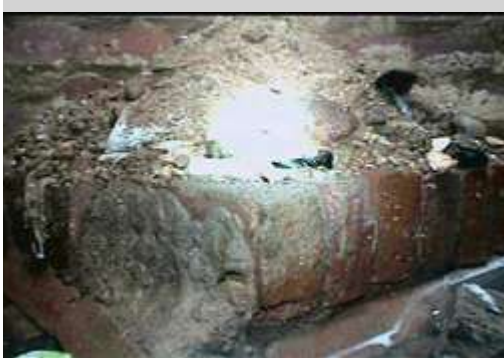
Defect 3

Condition: ☐ Sound ☐ Cracked ☐ Root Intrusion ☐ Deteriorated ☐ Leaks ☒ **Debris**

bench debris

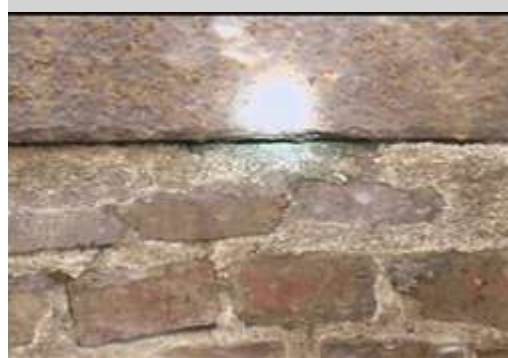
Defect 1

Condition: ☐ Sound ☐ Cracked ☐ Root Intrusion ☐ Loose Brick ☒ **Deteriorated**

chimney deteriorated

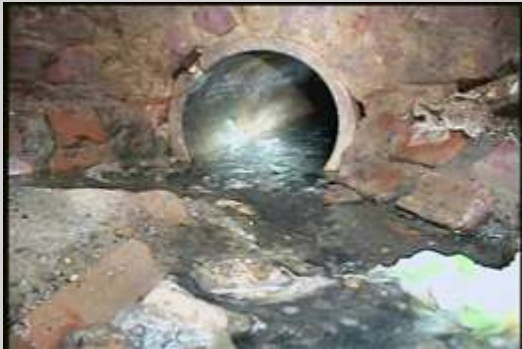
12 O'Clock Outflow

8 in. Circular Gravity Sewer
Pipe Out @ 12 O'Clock

Invert Depth: 7.29 (ft.) Flow Characteristics: **Fast**

Deposits: ☒ None ☐ Mud ☐ Sludge ☐ Debris ☐ Grease

Infiltration: **None** Pipe Seal Cond: **Unknown**

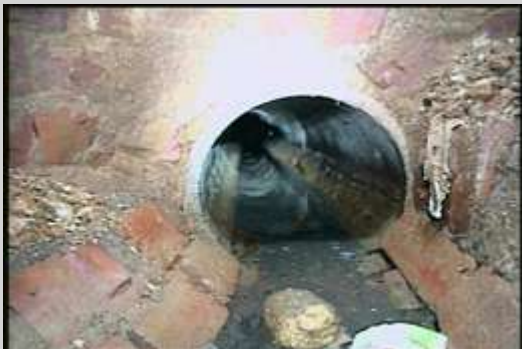
3 O'Clock Inflow

8 in. Circular Gravity Sewer
Pipe In @ 3 O'Clock

Invert Depth: 7.28 (ft.) Flow Characteristics: **Slow**

Deposits: ☒ None ☐ Mud ☐ Sludge ☐ Debris ☐ Grease

Infiltration: **None** Pipe Seal Cond: **Unknown**

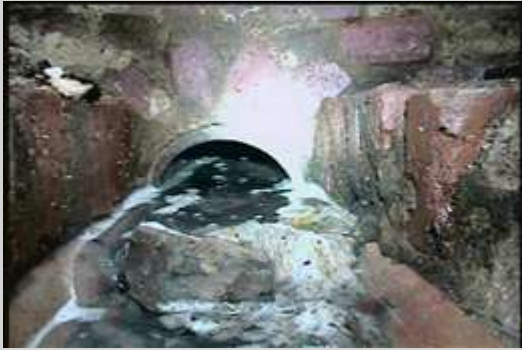
6 O'Clock Inflow

Pipe In @ 6 O'Clock

Invert Depth: **7.19** (ft.) Flow Characteristics: **Fast**

Deposits: ☒ None ☐ Mud ☐ Sludge ☐ Debris ☐ Grease

Infiltration: **None**

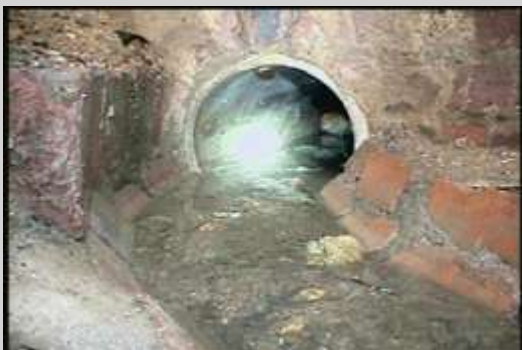
9 O'Clock Inflow

Pipe In @ 9 O'Clock

Invert Depth: **7.27** (ft.) Flow Characteristics: **Slow**

Deposits: ☒ None ☐ Mud ☐ Sludge ☐ Debris ☐ Grease

Infiltration: **None**
